Manhole Inspection Summary

Manhole # S33QQ_044MH

Insp Date: **4/23/07 10:30 AM**

Location Address: **2415 CHARLES ST**

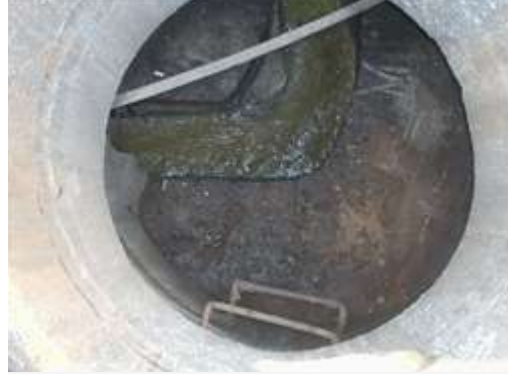
Top View

Evidence of surcharge - Bench debris.

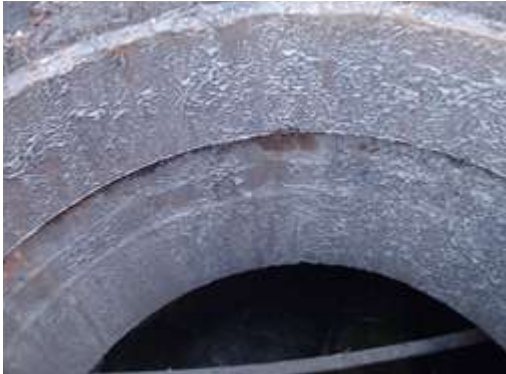
Defect

Frame leaks. Adjustment and Barrel infiltration - other side.

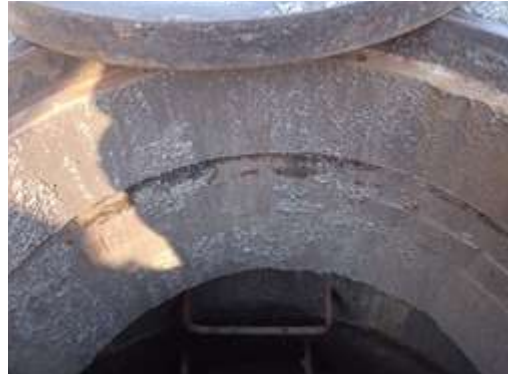
Defect

Frame leaks. Adjustment and Barrel infiltration.

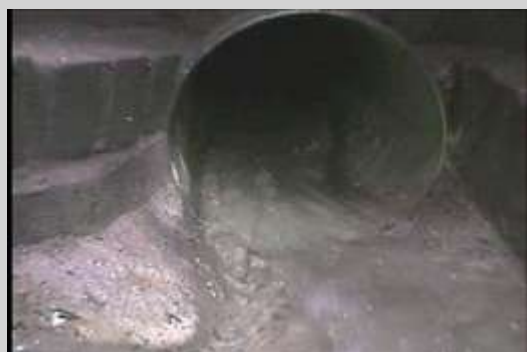
Pipe Out @ 12 O'Clock

Infiltration: **None** Pipe Seal Cond: **Unknown**

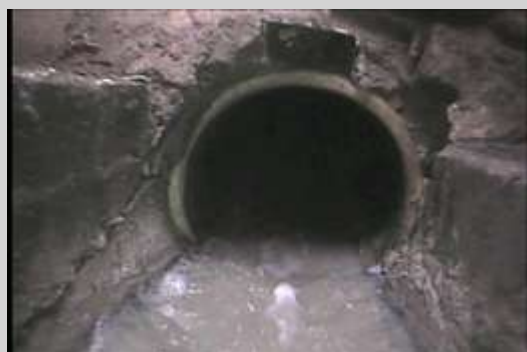
Pipe In @ 9 O'Clock

Infiltration: **None** Pipe Seal Cond: **Broken**
